**Issue Summary** Erratic HR Telemetry Readings with TR31/32/33 Treadmills

**Applies To** Treadmill models TR31, TR32 and TR33

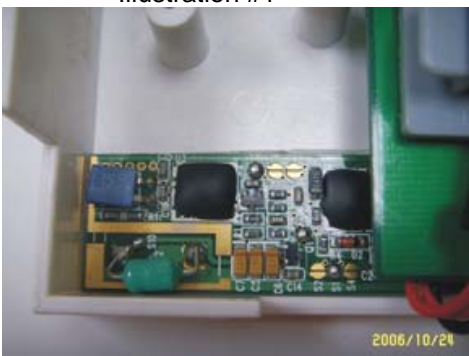
Illustration #1

<p><b>Detailed Problem Description</b></p>	<p>Irregular or absent HR readings when using wireless telemetry HR device. Heavy vibration increases problem.</p>
<p><b>Procedure Overview</b></p>	<p>1) Reposition telemetry receiver to alleviate vibration.</p>
<p><b>1) Reposition receiver</b></p>	<p>A) Disconnect power and allow 2 – 3 minutes for equipment to fully discharge before performing electrical work to avoid personal injury and/or damage to equipment.</p> <p>B) Remove screws from the keypad cover and remove the cover.</p> <p>C) Disconnect the telemetry receiver board and remove the telemetry receiver board wires from the handlebars.</p> <p>D) Open the display and remove the screws holding the HTR board in place. Lift the HTR board out of the way.</p> <p>E) Loosen the screws securing the display board.</p> <p>F) Connect the telemetry receiver board wires. Using double-sided tape on the back of the board, affix the telemetry receiver board in the lower left of the compartment, underneath the HTR board. (See Illustration #1)</p> <p>G) Replace the HTR board over the telemetry receiver board. (See Illustration #2)</p> <p>H) Secure excess wiring in the pedestal slot as shown in Illustration #3.</p>
