Issue Summary Motor Cover Removal

Applies To Treadmill models T630, T650 and T650M

Step by step instructions on removing the motor cover from the T630 and T650/M treadmills.

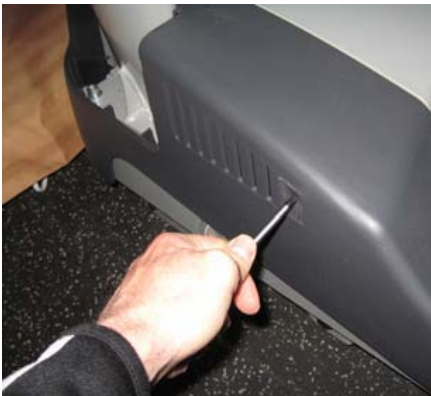
Illustration #1

- D) Push the pedestal Cover upward until it unsnaps. Remove the pedestal cover by lifting up and out.
- E) Locate the rubber cap on the side cover (just to the rear of the venting on the side cover.) Using a screwdriver, press the rubber cap inward to remove it. The rubber cap will fall to the floor. (See Illustration #1)

- F) Loosen, but **do not remove** the retaining screw exposed by removing the rubber cap in Step D.
- G) **Remove** the motor cover retaining screw near the rear of the pedestal base. (See Illustration #2)

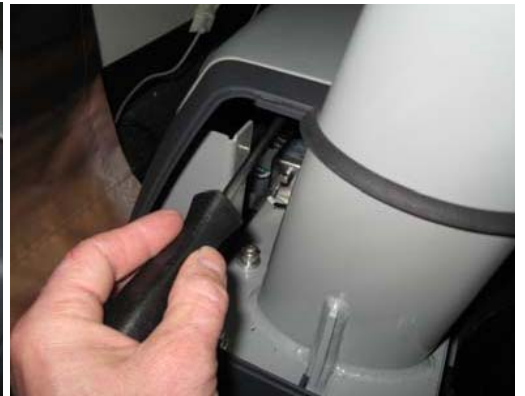
Illustration #3

- H) **Remove** the motor cover retaining screw near the front of the pedestal base. (See Illustration #3)
- I) Perform Steps C → H on the opposite side of the equipment.
